Integral optimization of the Quebrada La Honda water supply system: social and financial impacts in Villavicencio, Meta

Giselle F. Andrade Rondón¹

¹Corporación Universitaria del Meta, Colombia.

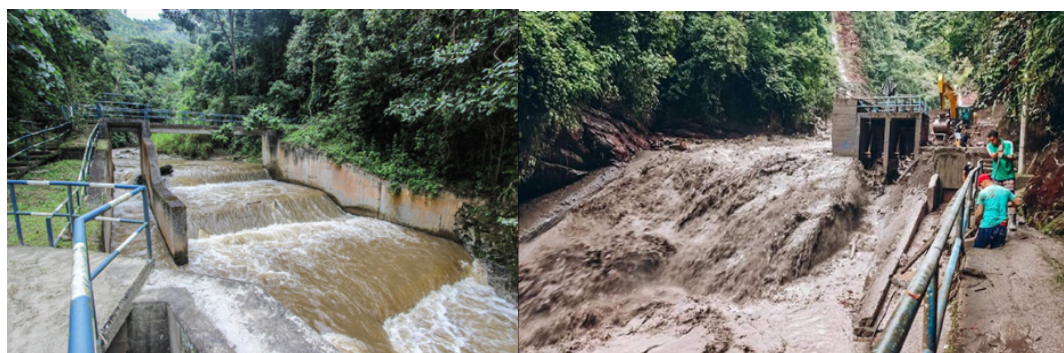
Figure 2. Behavior of the Intake Structure

In line with the above, the intake of the adduction system in the Quebrada La Honda sector has an irregular hydraulic capacity for water resource management. This irregularity becomes even more noticeable in the rainy seasons, as the infrastructure collapses due to the increase in water volume caused by the rainwater flowing into the source. The following figure shows a photograph of the contrast in the hydraulic capacity of the water intake in summer conditions and conditions of collapse.

Note: the image on the left shows the Bocatoma in summer; the image on the right shows the Bocatoma in the rainy season.

Figure 1 allows us to infer that many factors, such as the increase in the volume of water due to rainwater runoff, were not considered in the design, which suggests the subdimension of infrastructure. This oversight could have been avoided if an exhaustive study had been carried out on the behavior of the stream and the drainage network belonging to the hydrographic basin. An example of the relevance of this diagnostic study is represented by Mosquera⁽¹⁵⁾, who uses the methodology to determine the vulnerability of aqueduct supply sources proposed by the Institute of Hydrology, Meteorology and Environmental Studies (IDEAM). The following table shows the variables and indicators that every vulnerability study should consider in the design phase of catchment systems.

Based on the above information, the main proposal for improvement to optimize the adduction system in the Quebrada La Honda sector is to redesign the intake. Currently, the entire network faces significant financial losses due to the numerous restoration processes necessary due to its undersized and low hydraulic capacity to manage the volumes of water needed to supply the population. It is recommended that this redesign be thorough and consider all the variables previously described in figure 3 and the different methodologies established by national policies that dictate the design criteria for proper intake functioning. Although this measure represents a high public investment cost initially, it will result in notable savings in the long term since the financial resources allocated to constant repairs and restorations will no longer be necessary, and the maintenance cost will also be reduced.

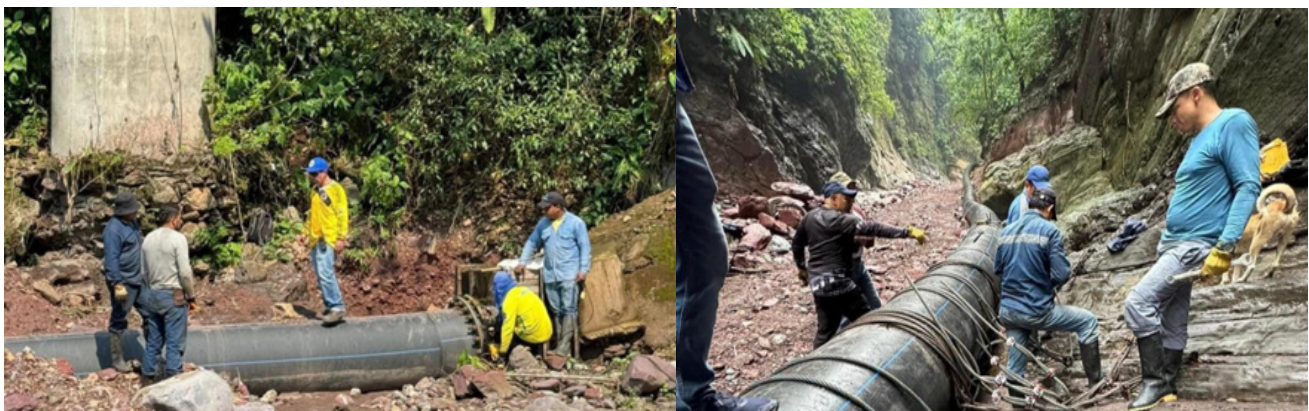
Figure 4. Repairs to the adduction system in Quebrada la Honda

However, in social terms, the effects of the system's collapse have been evidenced by the periodic suspension of the city's drinking water service. Since the infrastructure has been compromised mainly by torrential floods, the pipes have cracked, fragmented, and even split. An example is what happened in March of this year when there were service cuts in eight city sectors from six in the morning. This was due to infrastructure problems that required intervention in the adduction system from the Quebrada La Honda intake to the La Esmeralda drinking water treatment plant, as restoration and maintenance work had to be carried out on the system.

These service cuts caused the administration to grant a partial supply through the Bavaria pumping station during the period of the public service interruption. This presents an overload in the aqueduct system of the Bavaria station since supplying the activities of the Quebrada La Honda sector, access to the service of the primary beneficiaries of this station is compromised. In this case, there is endless news about constant interruptions in the drinking water service due to collapses in the infrastructure of the adduction system in Quebrada La Honda, as shown in the following figure.

In the same vein, in the design of the pipe, it must be taken into account that it must be made of a more resistant material than extruded aluminum, such as ductile steel. The latter offers excellent durability and resistance to internal and external pressure,⁽²⁰⁾ minimizing the risk of failures and leaks. In addition, ductile steel has an excellent capacity to withstand impacts and vibrations, and its flexibility allows it to better adapt to ground conditions. Using ductile steel will guarantee a longer lifespan for the pipeline system and be corrosion-resistant.⁽²¹⁾ However, it will also significantly reduce maintenance costs and service interruptions,⁽²²⁾ providing a more efficient and sustainable long-term solution for the water supply system in the Quebrada La Honda sector.⁽²³⁾
